RE-VEGETATION OF DISTURBED SLOPES

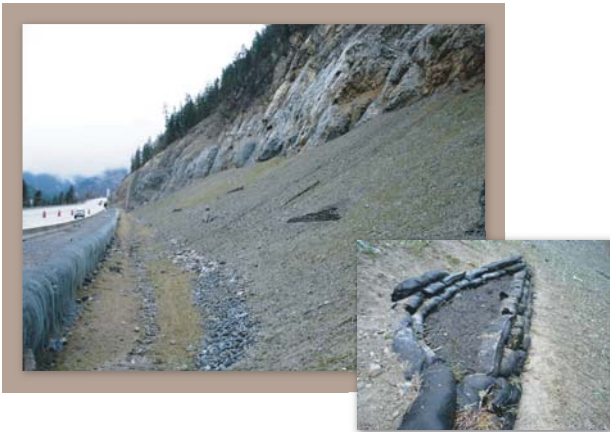
- 'Planting pockets' use filter fabric bags to provide a structural, reinforced pocket area containing topsoil to help 'islands' of plants become established, and thereafter spread on the slope through seed dispersion and/or root systems.

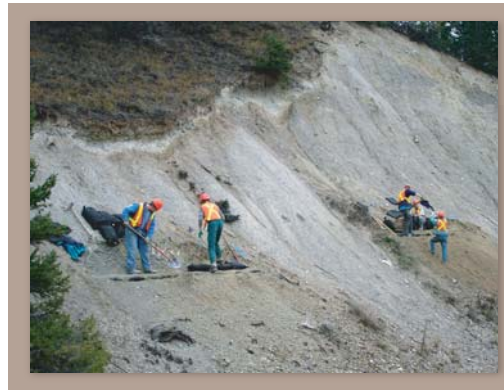
- Live 'planting bags' use filter cloth bags filled with topsoil and moisture-retaining material into which rooted plant stock is planted. This and other techniques are supplemented with the use of fast-growing cottonwood and willow cuttings.

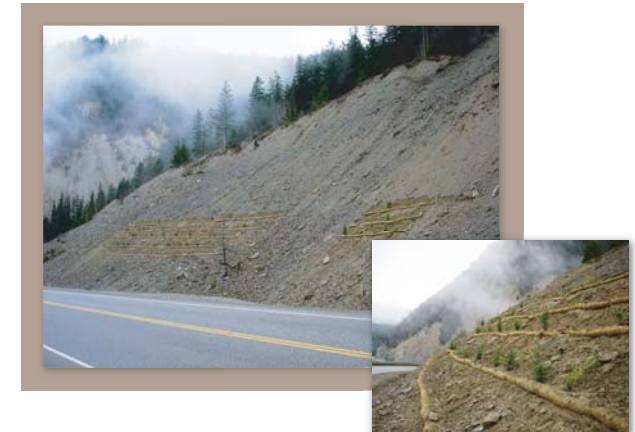
- Planting ledges are created with the installation of straw 'logs' along slope contours. These terraces encourage moisture retention and improve surface soil stability, while plantings of native vegetation become established.
